6.0 Turner Hole Watershed

6.1 General Description

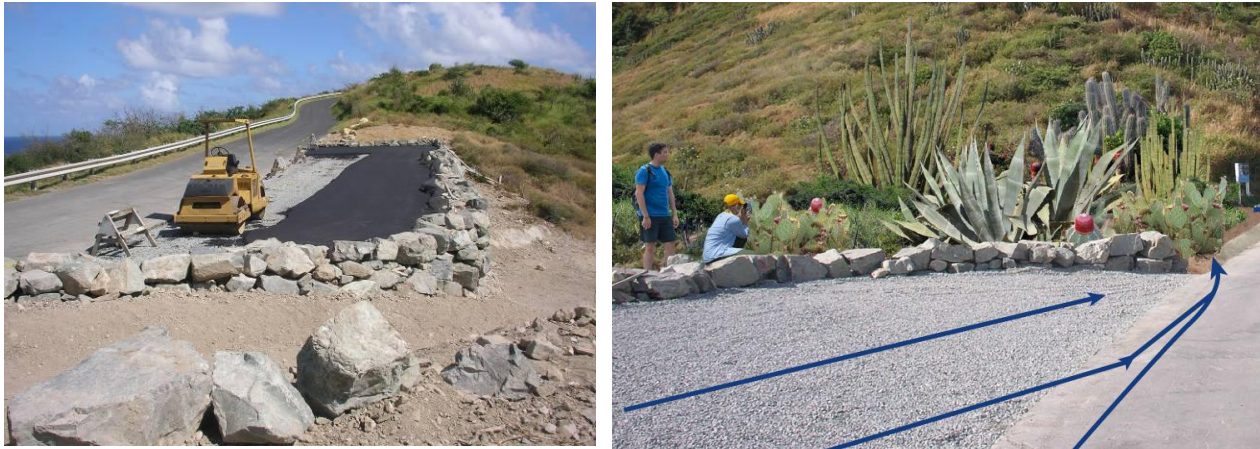
The easternmost point in the U.S. Atlantic seaboard is Point Udall. NOAA and VIRC&D are currently sponsoring/managing a trail restoration project involving the closing and stabilization of an existing trail and the construction of a small parking lot and new pedestrian trail. Parking lot construction is almost complete and trail stabilization features (i.e., water bars, traps, and bleeders) have been installed. Drainage from the road and the parking lot currently drain to the trailhead. There is potential for a small arid rain garden facility to be installed adjacent to the parking area to capture and treat stormwater using a xeriscaped landscape design, serve as a highly visible demonstration project, and protect the trailhead from erosion (Figure 6.2).

Figure 6.2. Construction of small parking lot at East End Bay Trailhead (left). Rendering of xeriscaped bioretention facility adjacent to parking lot (right).

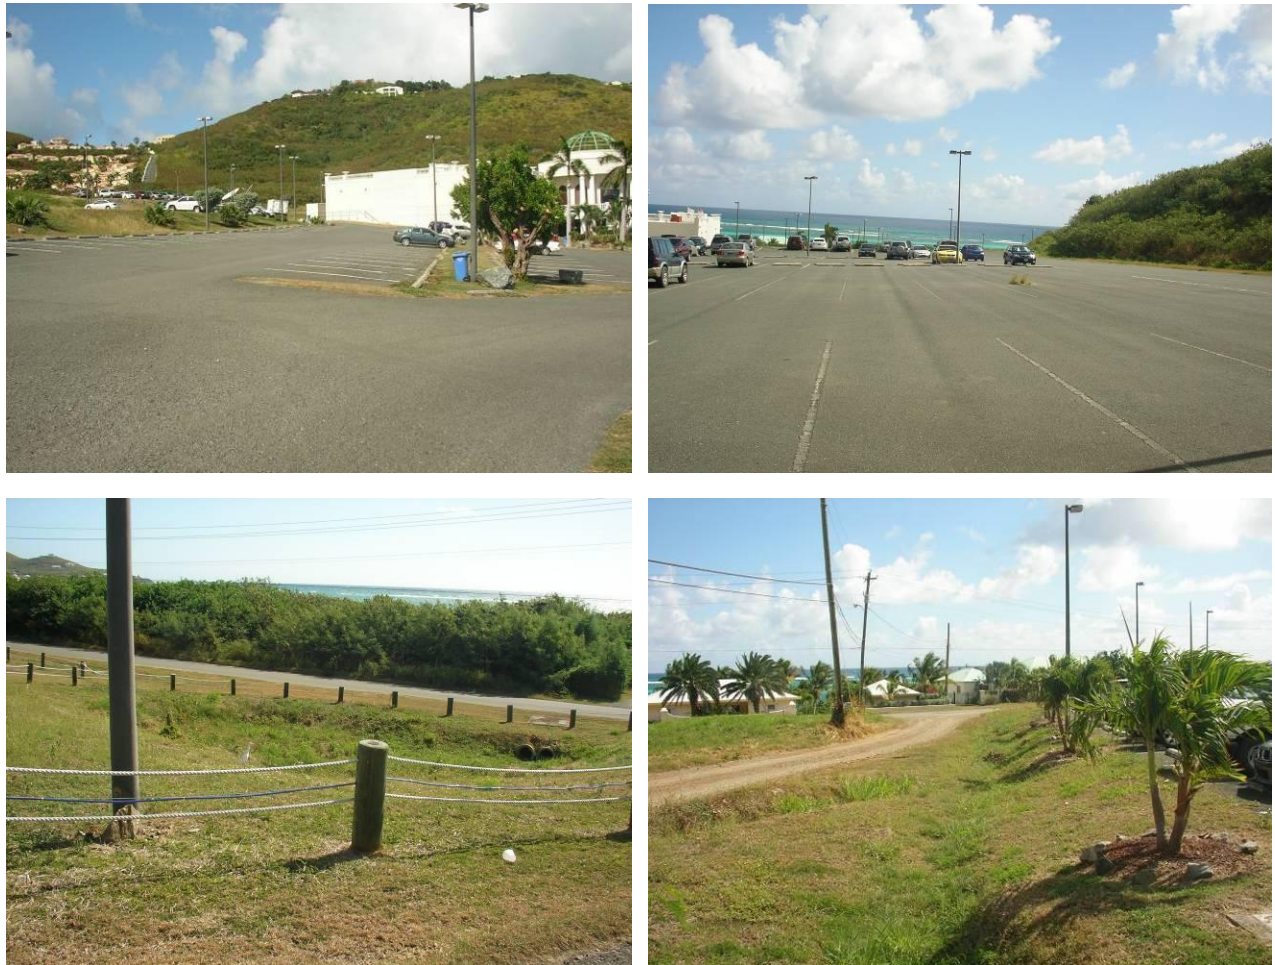
The Divi Carina Bay Casino is a feature of the larger Divi Carina Bay Resort. The Divi Casino is located along the north side of South Shore Rd. (Rt. 60) and is located in a generally low-laying flat area. The casino and surrounding paved parking lots comprise approximately 5 acres in impervious area—the largest concentration of impervious cover in the East End. The rear parking lot, to the northwest of the casino, drains over land to a small paved flume in the southeastern corner of the parking lot. This water is then directed through a shallow swale (gravel accumulation was observed at flume outlet). Runoff flows eastward behind the casino to a storm drainage inlet/pipe that discharges to the drainage channel that flows along the eastern edge of the main parking area to a detention basin on the southwest corner of the casino property, adjacent to the Divi Management Office. Stormwater from the detention basin is discharged through twin reinforced concrete culverts that merge into one 24-inch ductile iron pipe that leads to the beach immediately east of the Divi Hotel complex.

The existing drainage channel between the parking lot and roadway is filled with sediment. Modifying the existing detention basin to create a micropool wetland with a long flow path and baffle would increase storage and would help capture higher amounts of sediment. This would be an excellent location for a demonstration project, as the nearby facilities receive high amounts of public use.

Figure 6.3. Existing parking facilities at Divi Carina Bay Casino (top left and right). Existing detention basin at southwest corner of main parking lot (bottom left). Drainage channel around casino parking lot to the east and south (bottom right).

Stormwater management in the rear parking lot may be improved by constructing additional paved flumes that will discharge to an existing shallow swale along the east edge of the parking lot (Figure 6.3). Additional stormwater management can be provided within the primary parking lot via installation of several rain gardens and/or bioswales between parking aisles, in existing grass areas. This would aid in disconnecting impervious area, reduce the velocity of stormwater, and would help to reduce sediment and other pollutants.

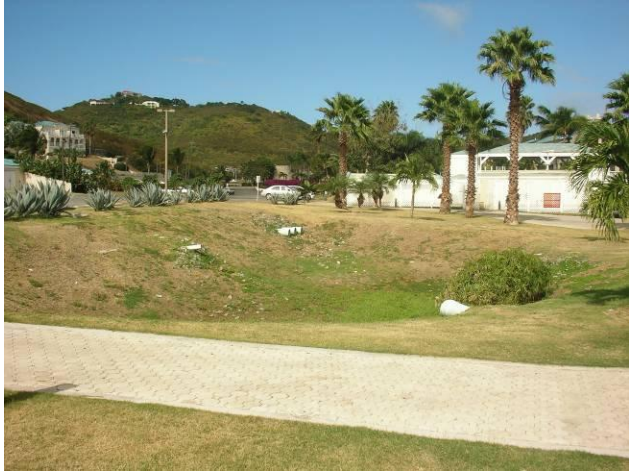
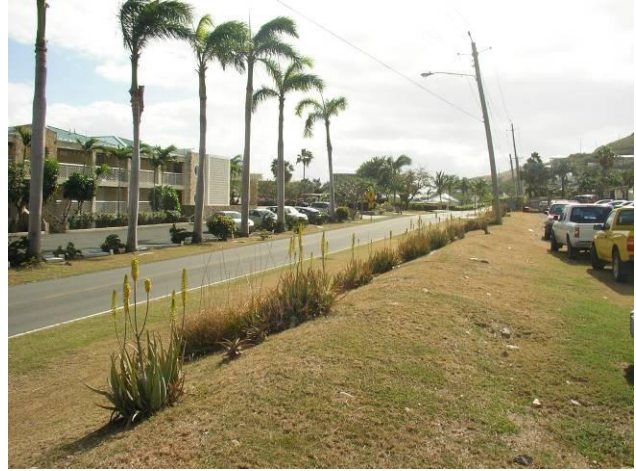
The Divi Hotel and Resort is located on the shores of Turner Hole in the western region of the watershed on South Shore Rd. The hotel, parking, and other appurtenant structures comprise approximately 4 acres of impervious area. An existing stormwater detention basin (one of the few in the East End) is located in front of the southwestern end of the main hotel building (Figure 6.4). A series of pipes convey drainage from the parking area as well as from a gut across the road. This gut flows between the tennis courts and Divi residential properties through three 16-inch PVC pipes beneath South Shore Rd. to the detention basin. The basin outlet is comprised of a 16-inch PVC pipe that discharges to the beach area behind the hotel.

Figure 6.4. Detention basin at Divi Carina Bay Hotel & Resort (left). View of Divi Hotel parking areas along South Shore Rd and potential area for a rain garden/swale (right).

The existing stormwater basin may be enhanced by expanding the basin to southwest, as feasible, then over-excavating and replacing excavated material with an organic soil to increase infiltration and storage capabilities. Expansion of the basin would require modification and relocation of the outlet structure.

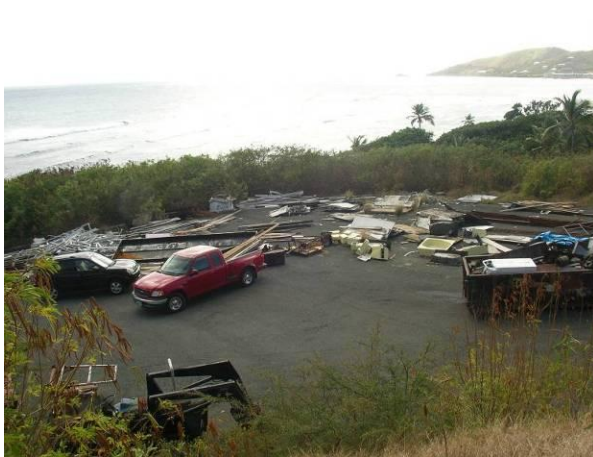
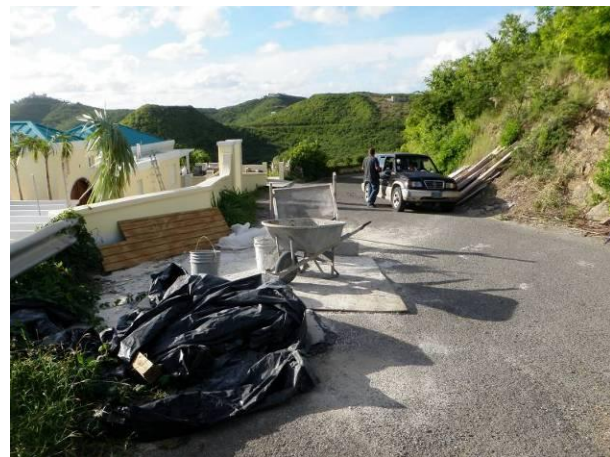
The existing Grapetree Bay Hotel building is located on South Grape Tree Rd. in the central portion of the Turner Hole Watershed overlooking Grapetree Bay and is currently in the process of being renovated. Extensive debris and demolition material from the interior of the building are being stockpiled in the parking lot. Stormwater sheet flows over this impervious area towards the ocean. There are currently no stormwater practices present on site. Installation of a rain garden within or adjacent to the parking area would assist in the treatment and attenuation of stormwater discharging to nearshore waters and would serve as a highly visible demonstration project for educational and outreach purposes, particularly since residential construction projects are also challenged by proper management of construction debris and material storage (Figure 6.5).

Figure 6.5. Parking lot and construction materials/debris storage at the Grapetree Bay Hotel (left). Material storage and staging at small residential construction site in Turner Hole (right).

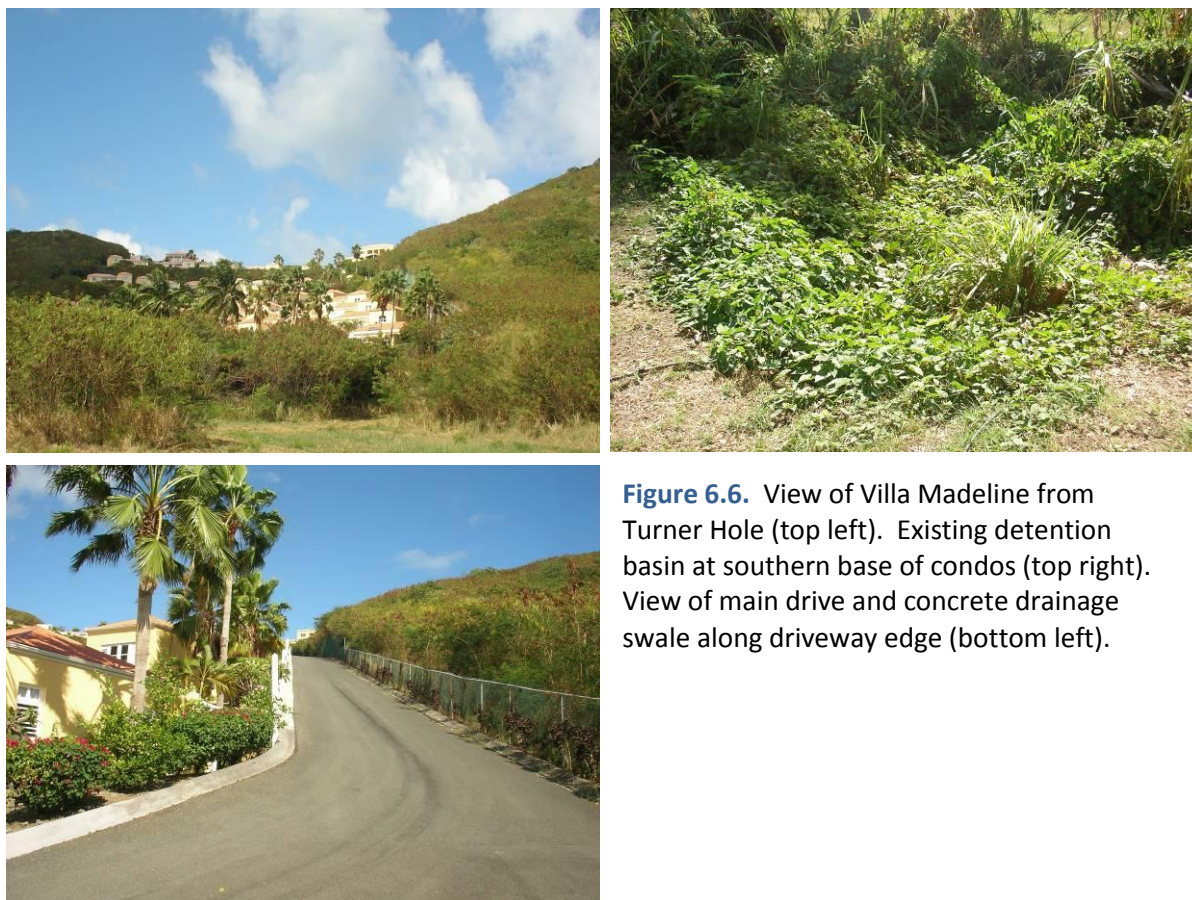
Villa Madeline is located along the ridgeline between Teague Bay and Turner Hole watersheds, with most of the area draining towards Turner Hole. Villa Madeline is accessed by Maggie Hill Rd. off East End Rd./Rt. 82 on the north shore, and by South Ridge Rd. of South Shore Rd./Rt. 60. Stormwater flows from the top of the development south to the base of the hill into an existing detention basin via two paved inlet flumes (Figure 6.6). The existing detention facility may be enhanced through minor improvements and maintenance activities. The existing basin seems to be undersized for the contributing drainage area; raising the berm surrounding the basin by approximately two feet would increase the storage capacity. In addition, a new forebay at the inlet location would facilitate easier maintenance and sediment removal.

Figure 6.6. View of Villa Madeline from Turner Hole (top left). Existing detention basin at southern base of condos (top right). View of main drive and concrete drainage swale along driveway edge (bottom left).

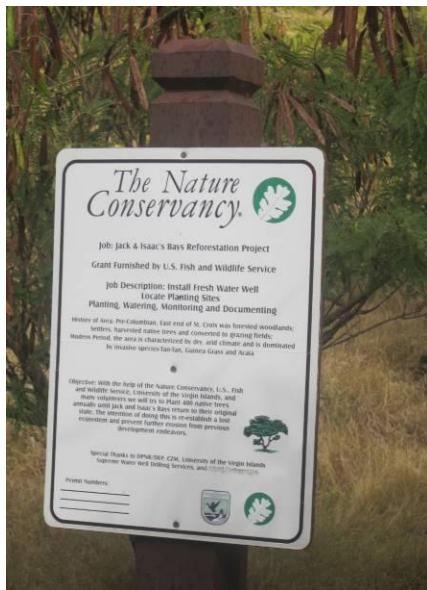
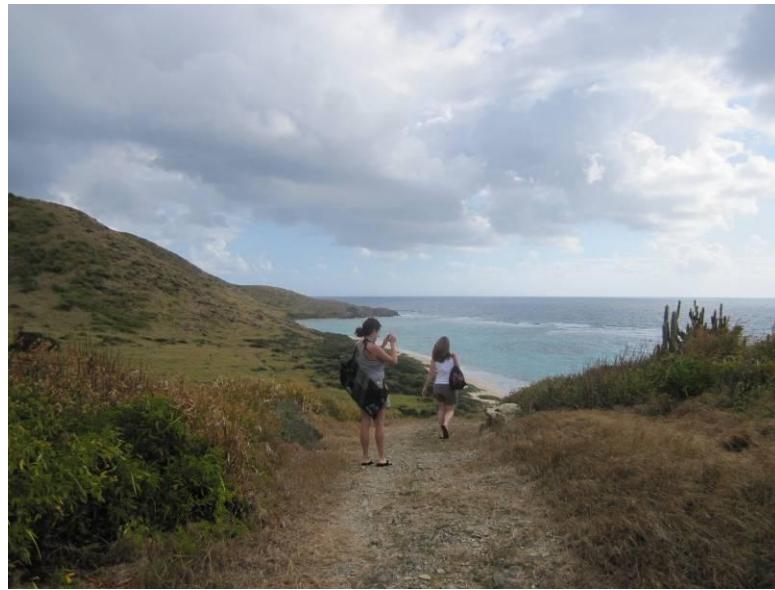
The TNC easement and hiking trails are well maintained and in very good condition (Figure 6.7). TNC personnel have been installing old marine mooring ropes anchored by rebar as water-bars to stabilize footpaths and prevent erosion. We have no recommendations for TNC trail management.

Figure 6.7. The Nature Conservancy signage and trail on the East End in Turner Hole.

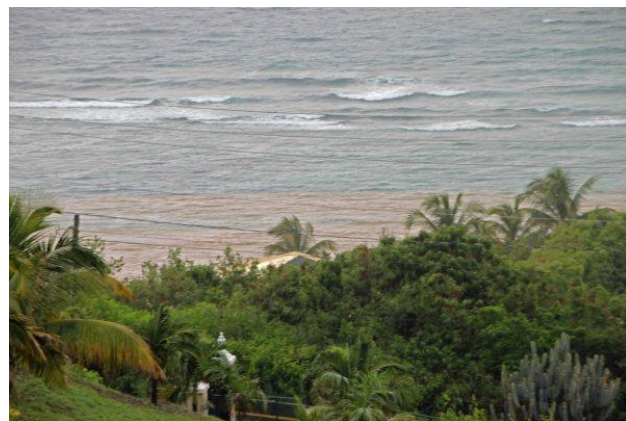
A new culvert was installed in July, 2010 on a residential lot in an effort to reduce active erosion of an existing gut, which accepts drainage from South Shore Rd. A sediment plume in Grapetree Bay observed by residents during the heavy rain events on July 19-20, 2010 was reported to have originated from this location (Figure 6.8). Property owners report that since culvert installation was completed, no additional sedimentation issues have occurred. HW did not visit this site during our field assessment and are unable to verify these reports; however, EEMP staff did conduct a

Figure 6.8. Sediment plume in Grapetree Bay in July 2010 (photo courtesy of Kathy LeGrange/Dave Rivers)

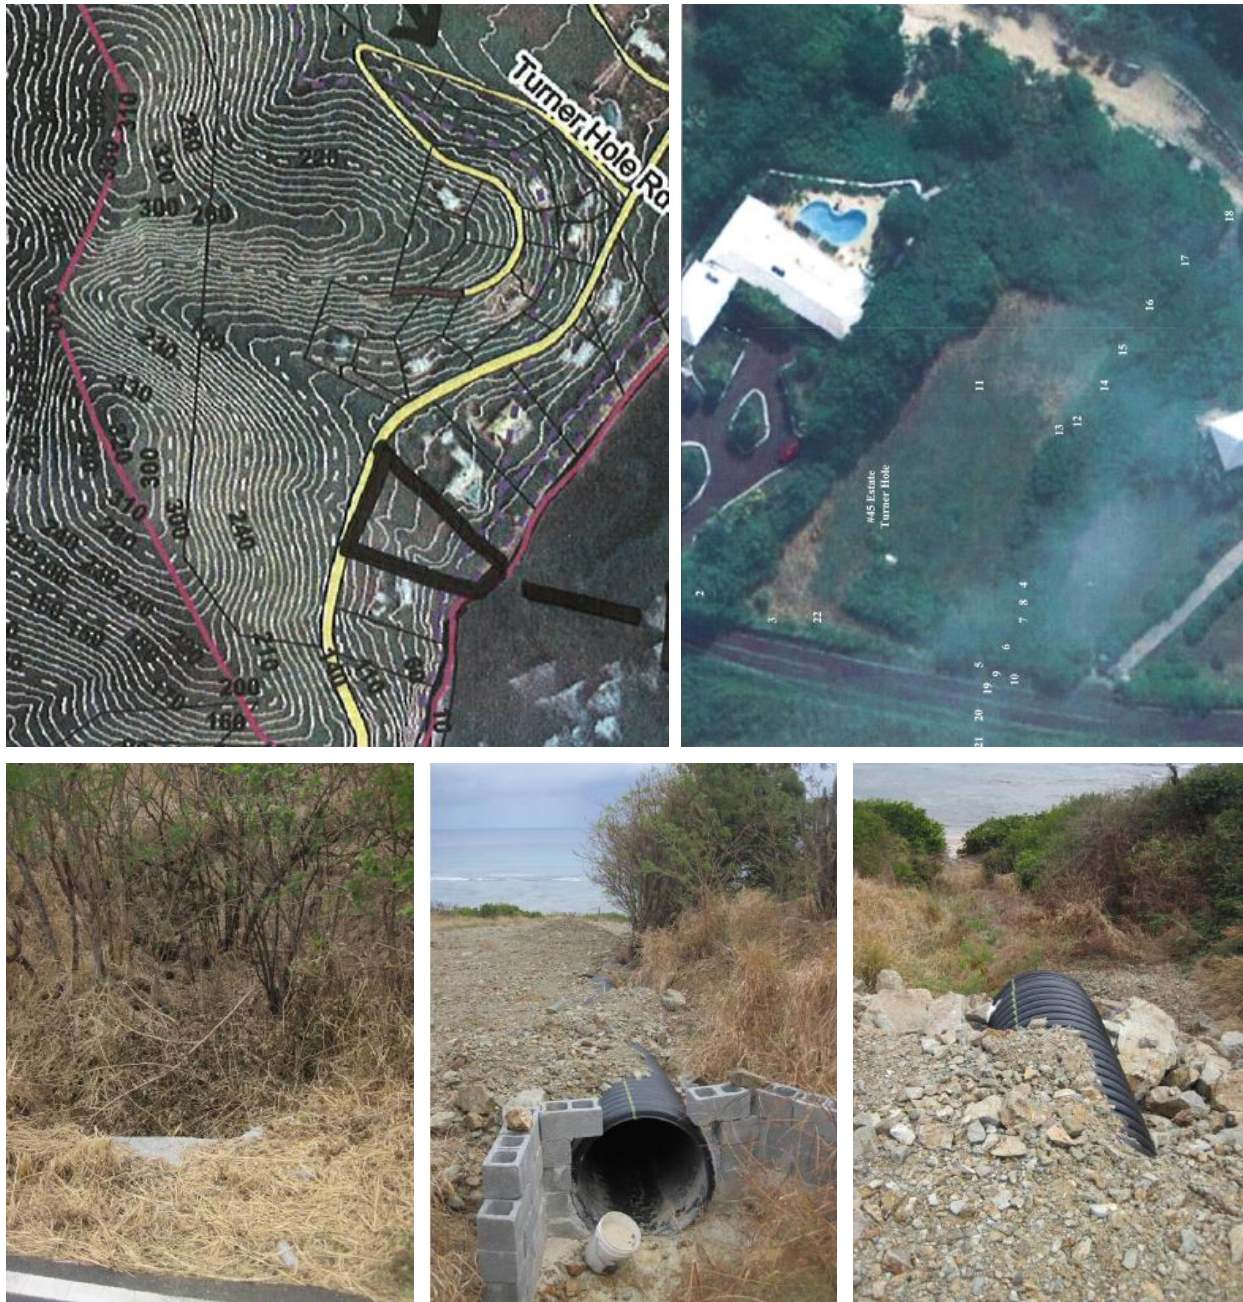
follow-up site visit in March to document conditions (Figure 6.9). Property owners report that because this culvert accepts secondary drainage from the road, the DPW was actively involved in the design/permitting of the project. HW has not reviewed hydrologic/hydraulic calculations used to size the culvert. From the photos, it is not clear if adequate outfall protection has been provided at the discharge location to prevent further erosion, although the property owners have indicated that during active construction, berms, rip rap, and haybales were used to prevent erosion and that the outfall is stable. This is another example illustrating a number of issues that should be addressed during the development of a comprehensive gut management strategy for the territory including policies related to piping of natural guts; gut buffer management; land subdivision, and permitting in relation to natural drainages.

Figure 6.9. (From top left to bottom right) Parcel location; aerial photo of site with location along channel/culvert where photos were taken by EEMP staff; looking at gut above road crossing; new culvert inlet on property, and culvert discharge to bay (photos from EEMP staff on March 14, 2011).

Culvert Repair/Maintenance		
New culvert/piped gut at South Shore Rd.	Investigate need for additional outlet stabilization from newly installed culvert to prevent slope erosion at discharge location	High
¹ ID matches basemap locations and field sheets in the Appendix.
